SULPHIDE CORROSION PRODUCTS IN CARBON STEEL AFTER PROLONGED SERVICE IN LOW-SULPHUR REFINERY ENVIRONMENT

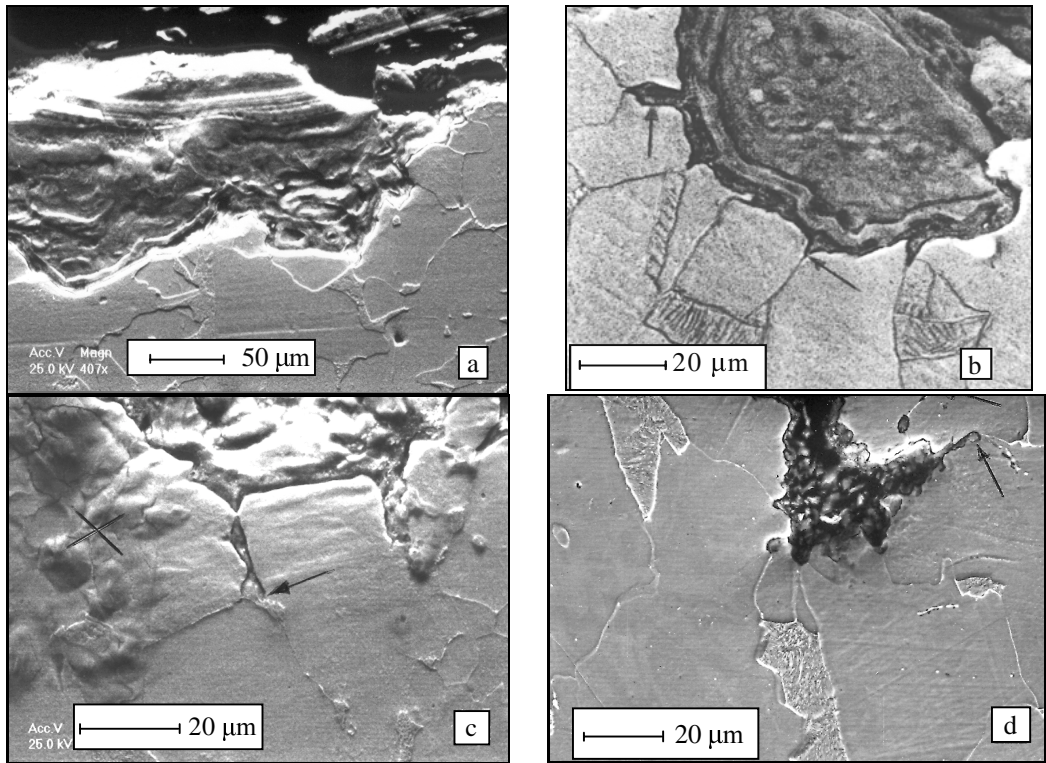
In Figs. 1(a)-(d) through 2, 3(a),(b) the SEM micrographs of the sulphur-attacked steel surface, i.e. the inside surface (IS) of the tube are presented. In Fig. 1(a) a crumbled, multi-layer scale on the surface is shown, and the chemical composition of some iron/sulphur-rich layers of the scale in an open shallow pit is described in Fig. 1(b). Non-uniform progress of metal losses on the steel surface due to sulphide corrosion is indicated by pits situated on the surface: the open pits in Figs. 1(a)-(c), and the closed pit in Fig. 1(d). It can be seen that the sulphide corrosion preferentially proceeded along the boundaries of the ferrite grains and across the pearlite grains. This is marked by the sulphide scale penetrating the boundaries of the ferrite grains to a greater depth than the insides of these grains in Figs. 1(b)-(d), and the scale developing through the pearlite grains in Fig. 1c and Fig. 2. The latter micrograph was taken about 0.05 mm beneath the steel surface.

Fig. 1. SEM micrographs of the cross sections of the sulphur-attacked carbon steel showing iron sulphide scale on the steel surface of chemical composition (in wt. %) indicated in (b): Fe-82.55, S-17.45 (1), Fe-71.40, S-28.60 (2), Fe-79.46, S-20.54 (3) (EDS). The open pits on the surface (a-c) and the closed pit (d) are presented. Sulphide corrosion progress along ferrite grain boundaries (b, d) and through the perlite grain (c) is indicated by arrows. The centre of the brittle fracture area is marked by a cross

The SEM examinations revealed that the scale formed on the carbon steel under investigation contained both the sulphide corrosion products and the mechanically separated steel particles. It is evident in Fig. 3(b) that at the advanced stage of the corrosion the ductile-mode failure of the subsurface layer developed, while at the earlier stage in Fig. 1(d) some brittle fracture prevailed.

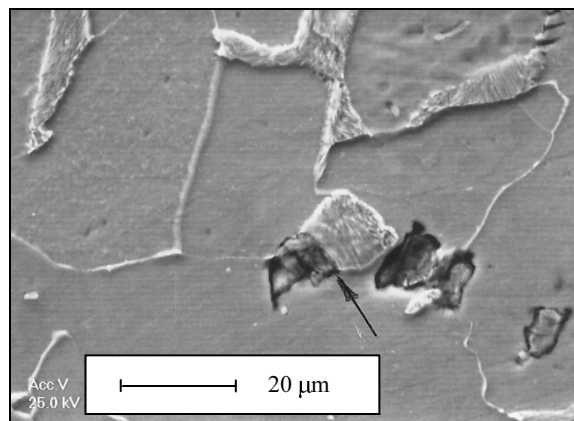
Fig. 2. A SEM micrograph of the cross-section of the sulphur-attacked carbon steel illustrating iron sulphide inclusions about 0.05 mm beneath the steel surface. Sulphide corrosion progress through the perlite grain is indicated by an arrow

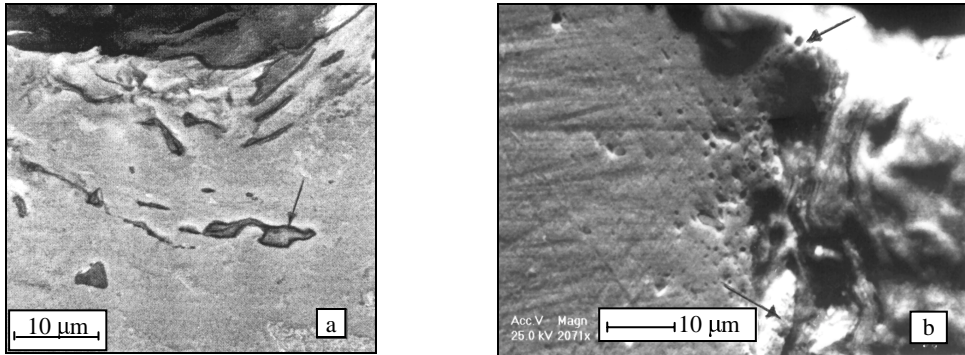
Figs. 3(a), (b) illustrate a mode of damage to the steel at an advanced stage of the sulphur attack when there were no longer pearlite grains in the subsurface metal layer and some ferrite grain boundaries disappeared. In this ferrite matrix area irregular iron sulphide inclusions formed. Conglomerations of the inclusions weakened the strength of the subsurface layer to such a degree that some parts of the layer fall off.

Fig. 3. SEM micrographs of the cross sections of the sulphur-attacked carbon steel showing irregular iron sulphide inclusions beneath the steel surface. In (a) the inclusion of chemical composition: Fe-80.05 wt. %, S-19.95 wt. % is indicated by an arrow. In (b) impaired steel particles separating from the surface are indicated

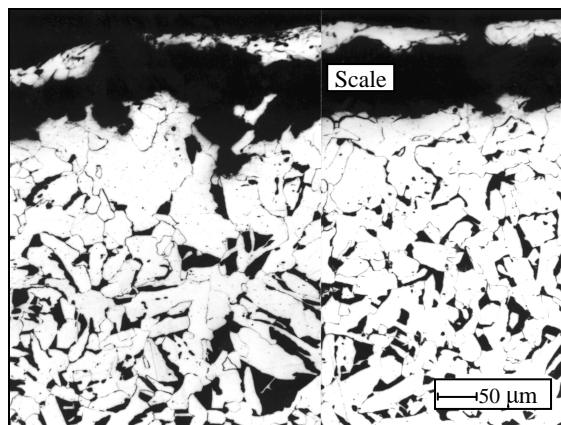
In some areas beneath the surface continuous layers of an internal iron sulphide scale formed. The internal scale probably developed due to the growth and the linking of the subsurface pits and the irregular iron sulphide inclusions in the subsurface area. A part of the scale that was recorded using optical microscope is presented in Fig. 4. The microstructure of the steel showing white ferrite grains and black pearlite grains can be seen. The parts of the material close to the both edges of the scale were decarburized that is evidenced by an increased amount of the ferrite grains at the expense of the pearlite grains.

Fig. 4. An OM micrograph of the cross sections of the sulphur-attacked carbon steel showing internal sulphide scale. Decarburization of the steel close to the scale is evidenced by the increased amount of white ferrite grains at the expense of black pearlite grains

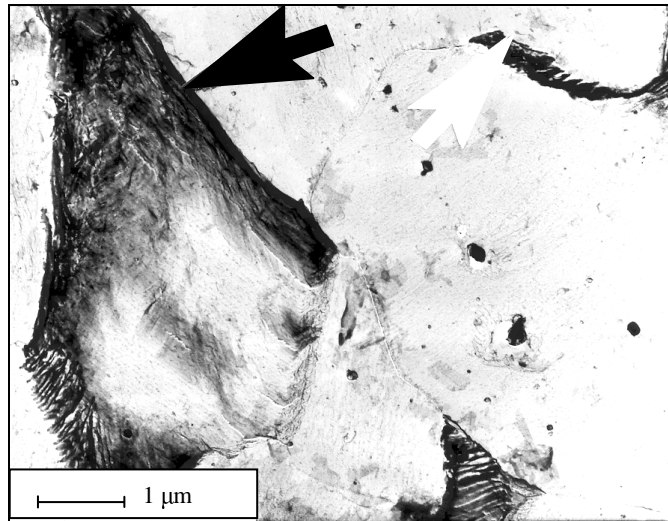
TEM/EDS examinations of the ex-service carbon steel revealed that a remarkable degradation of cementite took place under the influence of the sulphur. The results of the EDS analyses shown in Table 3 indicate that big amounts of sulphur were present in the degraded particles situated beneath the IS of the tube and down to a depth of 3.5 mm. The greatest concentration of sulphur was found at 0.2 mm beneath the surface and the concentration gradually decreased towards the middle-wall. The degraded particles were also enriched in tramp elements: manganese, chromium and silicon. The diffraction analysis of the degraded particles indicated their heavily deformed quasi-crystalline structure. In Fig. 6 an example of some degraded precipitates within a pearlite grain are presented. Some damage to lamellar microstructure of cementite and a partial disintegration of the pearlite grain may be seen. A total disintegration of the sulphur-attacked grains resulted in formation of a decarburized layer beneath the surface that was presented in Figs. 3, 4.

**Fig. 6.** A TEM micrograph of the carbon extraction replica of the ex-service carbon steel showing degraded cementite precipitates within the pearlite grain (black arrow) and at the boundary of ferrite grains (white arrow)

TEM/EDS examinations of ferrite grain boundaries revealed the presence of long and thin, isolated inclusions (Fig. 6). The greatest concentration of the precipitates was found close to the steel surface. Their composition was more differentiated than the composition of the pearlite-related particles. There were precipitates similar to the former and particles containing sulphur mainly; one precipitate similar to manganese sulphide was also recorded (Table 4).
