Jerzy Labanowski

Gdańsk University of Technology,
Department of Materials Science and Engineering,
Gdańsk, Poland

ASSESSMENT OF STRUCTURAL CHANGES AT IN-519 CAST STEEL REFORMER TUBES

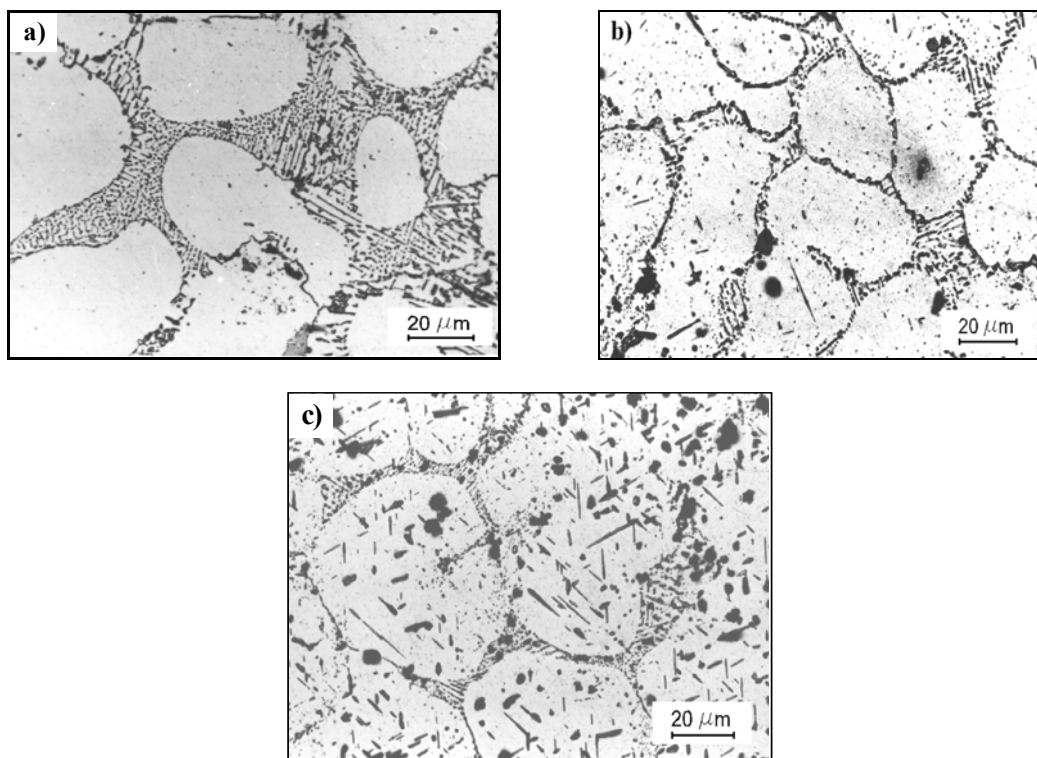
Fig. 2. Microstructures of IN-519 cast steel tubes, (a) non-degraded sample, after 24000 h (b) and 30000 h (c) operation in reformer furnace

The non-degraded, reference structure of IN-519 alloy (PM), showed the dendritic columnar austenite grains located perpendicularly to tube walls. The structure consists of austenitic matrix with a proportion of primary inter-dendritic eutectic niobium carbides and chromium carbides. The thin semicontinuous network of eutectic carbides can also be seen in the interdendritic areas (Fig. 2a). The EDS analysis showed that some of eutectic carbides are Nb-carbides and others are Cr-carbides. The original morphology of eutectic carbides has been modified during the long time of operation at elevated temperatures when certain coalescence has taken place. The structure of samples after 24000 h still contain lamellar eutectic of primary carbides, but the coalescence process has formed incomplete continuous network of primary carbides (Fig. 2b). Secondary carbides (mainly Nb carbides) were observed within the grains, but to a rather varying degree, both in size and amount. In addition to the small and round carbides inside austenite grains, also coarser and plate or needle-like precipitates of sigma phase were observed. Various amounts of sigma phase and degree of carbide coalescence were revealed.

The degree of structure degradation in the specimen after 30000 h operation was greater than in "24" samples (Fig. 2c). The carbide coalescence process was more advanced and quantity of lamellar eutectic decreased, but it still existed. The grain interiors were filled with needle-like sigma phase precipitates and dispersed NbC carbides.

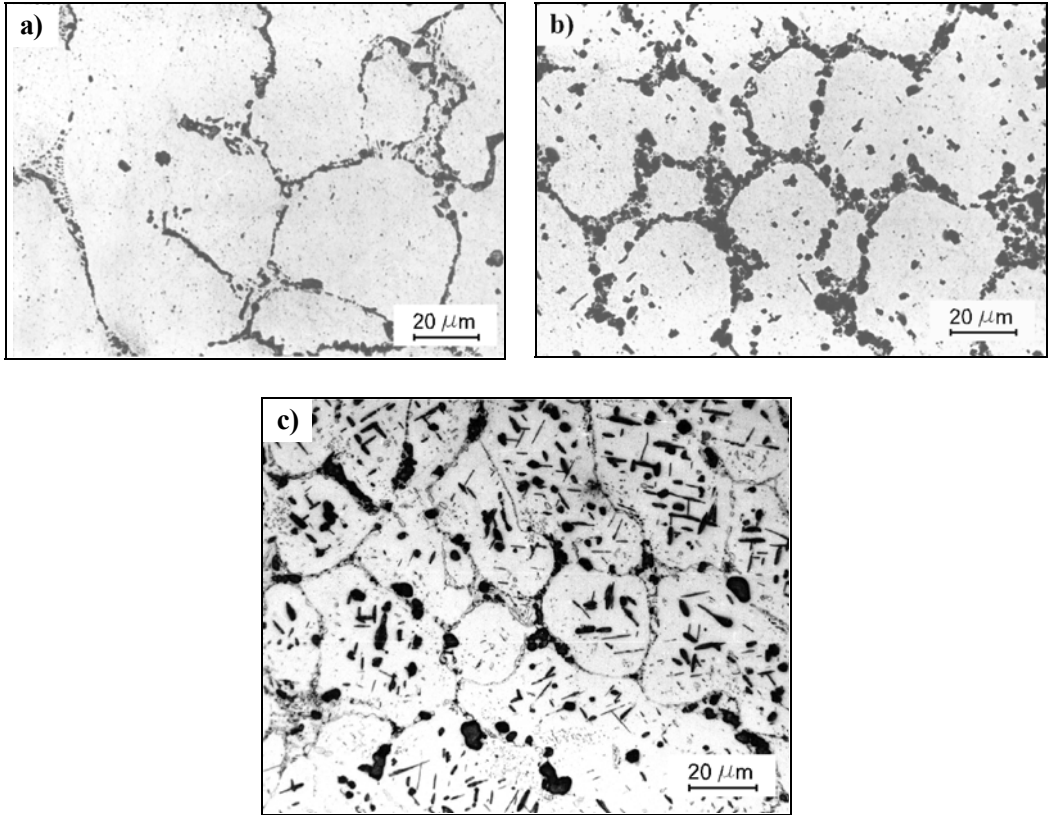
Fig. 3. Microstructures of IN-519 cast steel tubes after 44000 h (a), 72000 h (b), and 95000 h (c) operation in reformer furnace

The structure of the 44000 h sample consists of continuous network of coalesced carbides around austenite grains with only trace of primary eutectic structure. Little amount of sigma phase was detected inside the austenite grains (Fig. 3a).

The similar structure was found in 72000 h sample (Fig. 3b). In this case, the semi continuous coarse network along austenite grains consists of Cr and Nb carbides. Sigma phase was also present in the structure in the form of blocky precipitates. A small number of creep voids were found in the structure. The voids were formed at the interface between matrix and primary carbides or between matrix and the blocky sigma phase. The voids were rather small (up to 8 μm) and limited in number, scattered with no tendency to lining.

The structure of 95000 h (Fig. 3c) was similar to "72" sample, but unetched structure revealed a great number of creep voids. The voids are becoming aligned along dendrite boundaries. Aligned voids coalesced into fissures (up to 800 μm) were detected close to the inside surface of the tube (Fig. 4a,b).

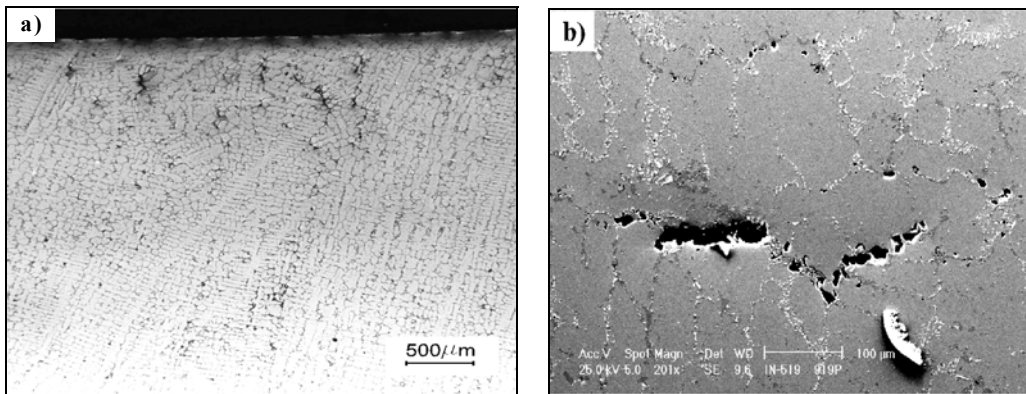
Fig. 4. Microstructures of IN-519 cast steel tubes. Voids aligned along dendrite boundaries
