SULPHIDE CORROSION PRODUCTS IN CARBON STEEL AFTER PROLONGED SERVICE IN LOW-SULPHUR REFINERY ENVIRONMENT

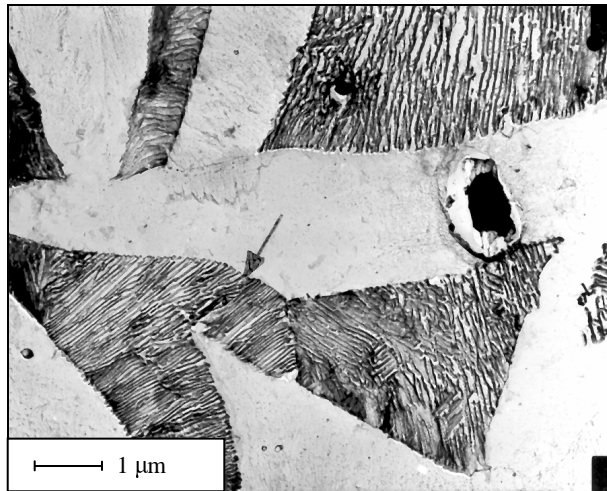
Fig. 5 shows a TEM micrograph of the carbon extraction replica of the as-received carbon steel. Cementite lamellae within a pearlite grain are presented. The diffraction analysis confirmed that they were of Fe_3C type. According to EDS analysis the lamellae contained mainly iron, and small amounts of sulphur and tramp elements, such as manganese, chromium, silicon (Table 2).

Fig. 5. Fig. 4. A TEM micrograph of the carbon extraction replica of the as-received carbon steel showing cementite lamellae within a pearlite grain
