Jerzy Labanowski

Gdańsk University of Technology,
Department of Materials Science and Engineering,
Gdańsk, Poland

ASSESSMENT OF STRUCTURAL CHANGES AT IN-519 CAST STEEL REFORMER TUBES

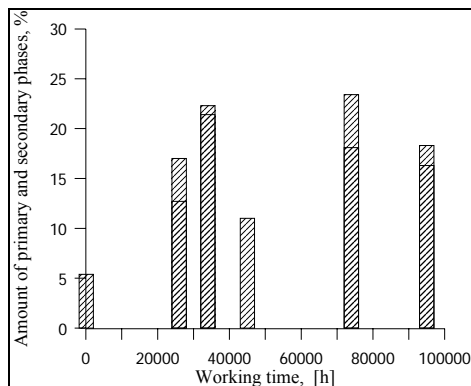
Fig. 5. Total amount of primary and secondary precipitates existed at IN-519 alloy structure after long term service at elevated temperatures

This simple quantitative description of the degree of structure degradation shows that structural changes during the operation time are not uniform and change in a non-monotonic manner with operating time. Moreover, the structures of the samples taken from the same reformer tube, used in the same conditions also can differ in quantity and form of precipitated phases. Generally, metallographic observations revealed that the various transformations took place in IN-519 cast steel tubes structure during operation time in the reformer furnace. These transformations are listed in Fig. 6.
